# TERRA-COM

## Emergency Spill Response Case Study Duval County

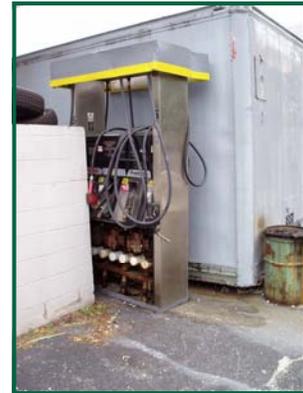
This site is an active retail fueling station located at 2404 Atlantic Avenue in Jacksonville, Florida. On the afternoon of October 27, 2003 an automobile accident that originated on Atlantic Avenue adjacent to the facility spilled over onto the facility resulting in a pickup truck hitting a fuel dispenser, separating the dispenser from the pump island (**Pictures 1 & 2**) and rupturing the product line below grade. The station mechanic on duty witnessed the accident and immediately engaged the system emergency shut off switch. In addition, shear valves for the three lines functioned properly, which limited the amount of fuel that was released.

**Picture 1**  
Dispenser Hit By Vehicle

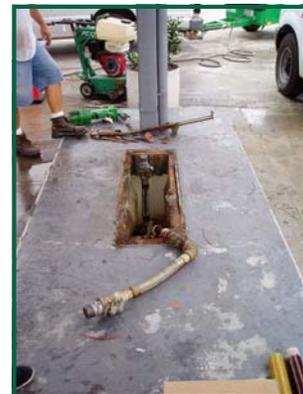
**Picture 2**  
Dispenser Island Immediately  
After Accident

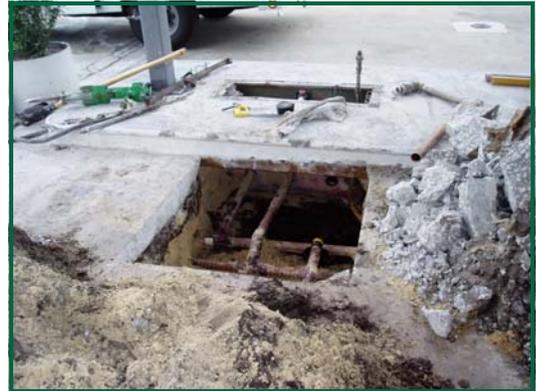
TERRA-COM personnel installed a grid of soil borings to delineate the extent of impacted soil. The initial area of excavation was laid out on a four foot by four foot horizontal grid. This 4x4 foot area was centered just south of the pump directly adjacent to the affected dispenser sump and was excavated by hand to a depth of three feet below the bottom of the concrete surface (**Picture 3**). Soil samples were taken from 1-foot intervals and screened utilizing a TVA. High soil headspace readings and some product staining in this area led to the decision to expand the excavated area.

**Picture 3**  
Initial Excavation

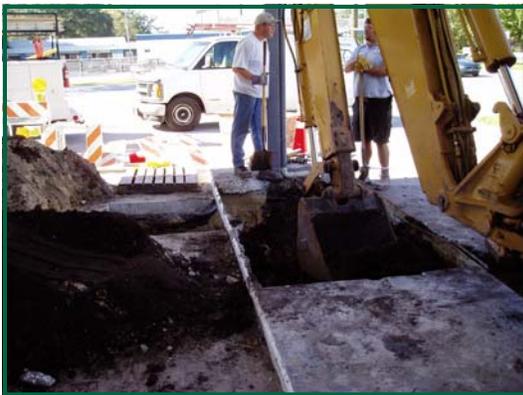
**Picture 4**  
Excavation of Dispenser Island

Approximately half of the pump island concrete was removed and a backhoe was brought in to aid in further excavation (**Pictures 4 & 5**). The additional area of excavation measured approximately five feet wide, thirteen feet long, and varied between four and six feet deep. Prior to completion

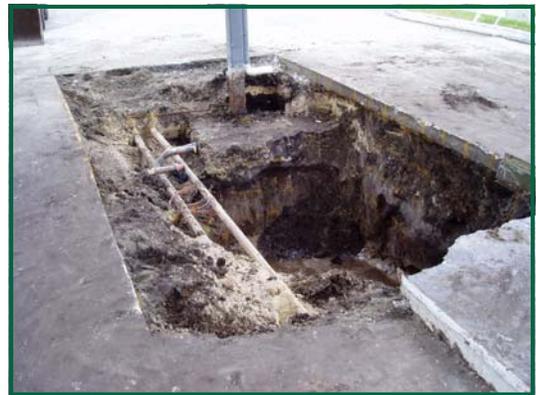
**Picture 5**  
Expanded Excavation

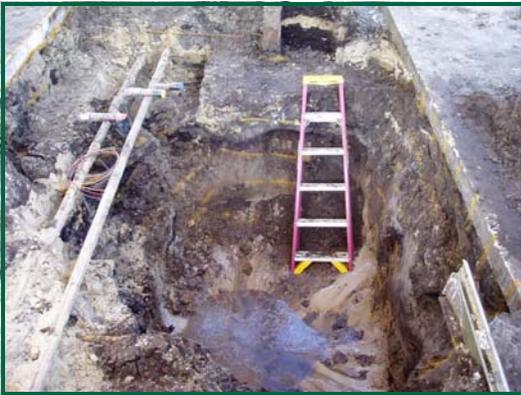
Upon completion of the excavation a confirmatory soil sample was taken directly beneath the line break for laboratory analysis. In addition, a sump was excavated in the bottom of the pit and allowed to fill with groundwater (**Picture 6**). No visual evidence or product was noted on the water. The hole was then properly backfilled and compacted and the pump island was re-built by a licensed tank contractor (**Picture 7**). FDEP issued a Site Rehabilitation Completion Order for this discharge on July 27, 2004.

**Picture 6**  
Visual Inspection of Groundwater

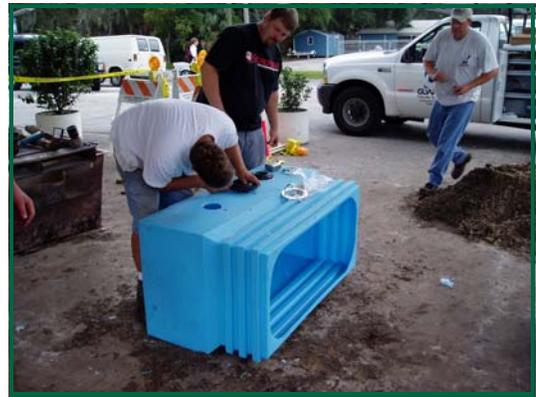
**Picture 7**  
Licensed Tank Contractor Rebuilding  
Dispenser Island
