TERRA-COM

Site Assessment Case Study Putnam County

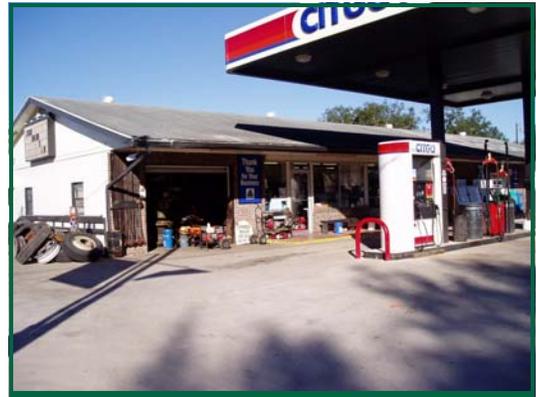
Picture 1
Bud's Grocery Facility

The site is a retail petroleum facility located on Bardin Road in Palatka, Florida. The site currently operates as an active retail fuel station, tire repair, grocery and feed store (**Picture #1**).

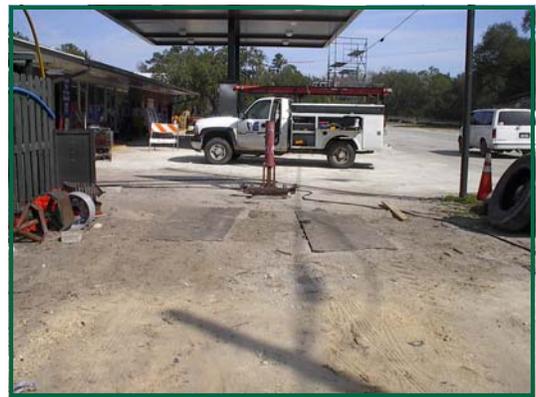
Picture 2
Canopy and Tank Areas

In 2004, the owner scheduled replacement of his underground storage tanks (USTs) and fuel dispenser canopy. At the time, the soil and groundwater contamination at the site had been investigated but had not been fully assessed. The Florida Department of Environmental Protection (FDEP) was requesting more assessment be performed prior to conducting any remedial effort. However, if the tanks and canopy were replaced (**Picture #2**), the soil contamination in this area would then be inaccessible to any future source removal effort and would likely require remediation with a mechanical or biological system at a later date. This approach would extend the site cleanup timeframe significantly.

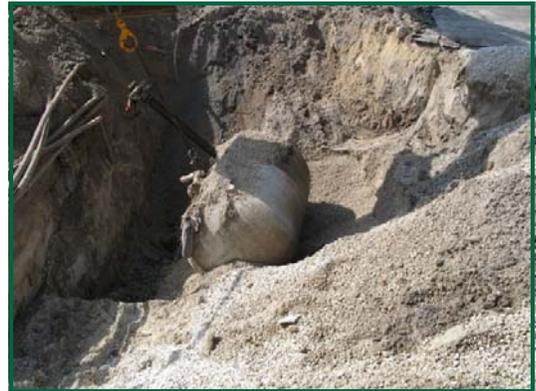
Picture 3
UST Removal and Replacement

TERRA-COM worked with FDEP and reached an agreement to move forward with the excavation of contaminated soil in the UST and canopy areas. The tanks and canopy were replaced in January and February 2004 (**Picture #3**) and a total of 548 tons of contaminated soil were removed during this effort (**Picture #4**). The site construction and environmental cleanup efforts were 'dove-tailed' together through TERRA-COM's negotiations with FDEP.

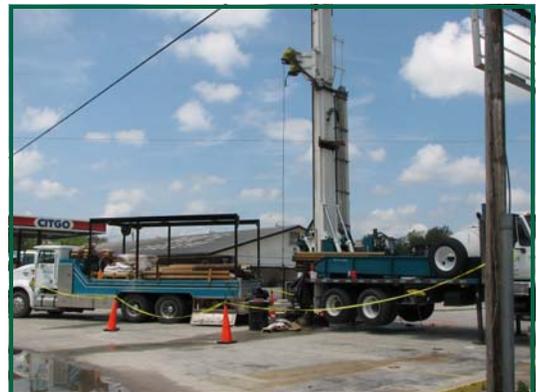
Picture 5
Rotosonic Drill Rig and Support Truck

Ongoing work at the site includes the installation of intermediate and deep wells using rotosonic drilling (**Picture #5**). This work will define the extent of the groundwater contamination (**Picture #6**), determine if the groundwater contamination has affected neighboring properties (**Picture #7**), and be used to determine the most cost-effective cleanup strategy while considering the business needs of the property owner.
