TERRA-COM

Environmental Consulting, Inc.

Storm Water Management & Erosion Control Case Study Sumter County

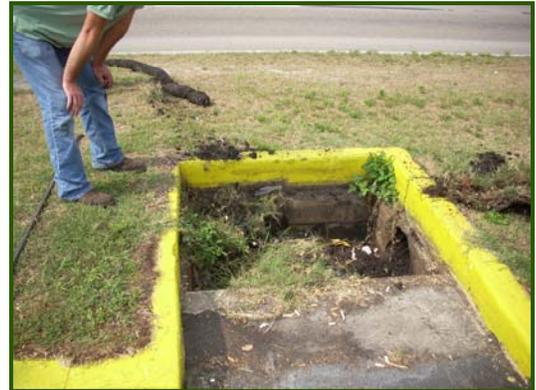
A travel center facility in Wildwood, Florida had been cited in consecutive years for a failure to maintain and provide proper storm water drainage and erosion control of over 50 acres of the property. Drains were not functional and spillways were overgrown and not able to be located (**Picture 1 & Picture 2**). Storm water ponds were filled with trash, silt and vegetation (**Picture 3**). Vegetation had grown to a height of over 15 to 20 feet, and water was running into the adjoining highway rather than into permitted retention areas and wetlands (**Picture 4**).

Picture 1
Overgrown Drain

TERRA-COM utilized an engineering/heavy equipment field team to determine the proper flow pattern and functionality of the drainage system and wetland design. The overgrown vegetation was cleared and damaged fencing was removed (**Picture 5**). A back spillway covered with over 2 feet of sediment and debris was located, repaired, and restored to functional use (**Picture 6**). Drainage contours were uncovered and properly dredged (**Picture 7**). Filtration systems were located and cleaned. All drains, culverts, outfalls and weirs were cleaned and returned to proper functioning order (**Picture 8**).

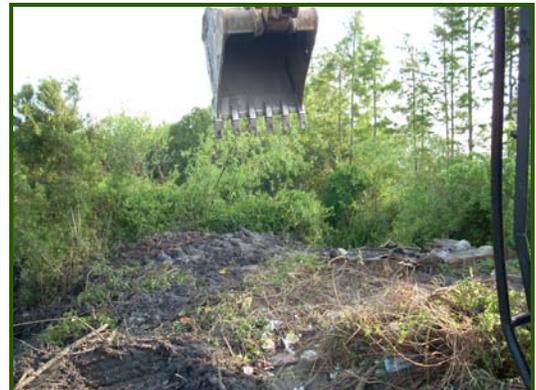
Picture 2
Overgrown Spillway
